## Integrated Analysis Using FTA, ASPEN HYSYS, And Lopa Of The 2019 HF Alkylation Unit Incident At The Philadelphia Energy Solutions Refinery

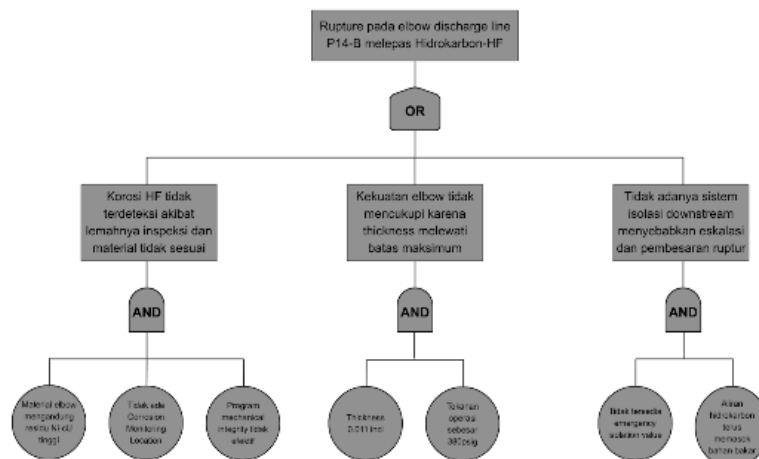
### Results of the Fault Tree Analysis

The FTA analysis conducted on the rupture of the P14-B discharge line elbow indicates that the top event resulted from a complex and interrelated set of causal factors. The FTA diagram shows that the rupture was not the result of a single failure, but rather a series of material, operational, and protective design failures that accumulated over a long period prior to the incident.

The FTA results identified three primary failure pathways, each of which contributed significantly to the rupture. The first pathway involved undetected HF corrosion, which occurred due to a combination of the selection of an elbow material with a high Ni Cu residue content, the absence of a corrosion monitoring location (CML), and an ineffective mechanical integrity program. These three basic events are connected via an AND logic gate, indicating that all of them are necessary to allow pipe wall thinning to reach a critical condition. The finding that the elbow experienced thinning to approximately 0.011 inches well below the minimum design limit reinforces the conclusion that corrosion detection failure was the dominant factor.

The second pathway confirms that the mechanical strength of the elbow is no longer sufficient to withstand the operating pressure. A pressure of approximately 380 psig in the discharge line, combined with extreme thinning of the pipe wall, causes internal stresses to far exceed the material's actual strength. These two conditions are also linked via an AND gate, which in the FTA indicates a necessary conjunction that is, failure can only occur if both conditions are met.

The third pathway indicates that the absence of a downstream isolation system contributed to the rapid escalation and enlargement of the rupture. Two key factors the absence of an emergency isolation valve and the continued flow of hydrocarbons supplying fuel exacerbated the release and amplified the initial impact of the leak. Overall, the FTA findings suggest that this incident resulted from multiple failures in material design, inspection, and process protection systems.

The primary mitigation measure identified as a key lesson learned is the need to strengthen the mechanical integrity program, specifically addressing HF corrosion mechanisms. FTA results indicate that undetected corrosion was the dominant factor in the rupture, exacerbated by the absence of corrosion monitoring locations (CMLs) on critical elbows. Therefore, the time-based inspection approach needs to be upgraded to a risk-based inspection, with an emphasis on components that have a high potential for degradation due to the HF environment and flow conditions. The inspection program must also be supplemented with the selection of appropriate non-destructive testing methods and inspection intervals determined based on actual risk, rather than solely on the equipment's operational age.

Furthermore, this incident serves as a lesson learned that material selection for HF service cannot rely solely on compliance with nominal specifications. Findings regarding high levels of nickel and copper residues in the failed elbow indicate that metallurgical mismatches can significantly increase the corrosion rate. Relevant mitigation efforts include tightening material selection standards for HF service, including more thorough metallurgical verification from the procurement stage through installation. Thus, the risk of failure due to material mismatch can be minimized early in the equipment's lifecycle.

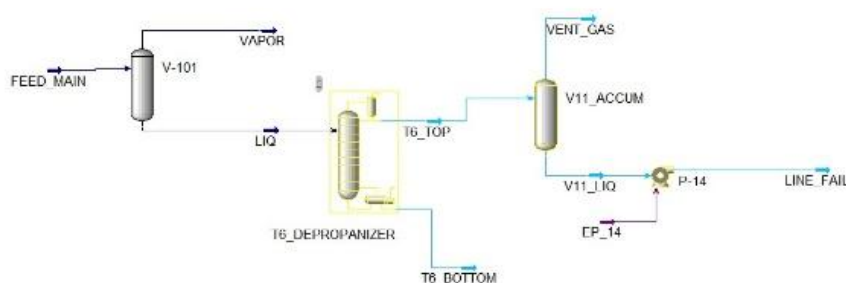
### Aspen Hysys Analysis Results

Process simulations using Aspen HYSYS were performed to understand the thermodynamic conditions of the fluid in the process segments relevant to the rupture point. Although the model is simplified, the flowsheet configuration includes a separation unit (V-101), a depropanizer column (T6), an accumulator (V-11), and pump P-14, thereby enabling it to represent the actual fluid path leading to the elbow that failed.

Simulation results show that the fluid entering P-14 and the downstream path is at medium-to-high pressure and is dominated by the vapor phase, which is consistent with the characteristics of the propane–HF mixture under operating conditions. The dominance of the vapor fraction indicates that when the elbow ruptured, the fluid was released as a high-velocity vapor jet. Such a jet possesses significant momentum, enabling rapid dispersion that forms a vapor cloud, which then ignites within a short time exactly as reported in the PES incident timeline

The simulation also shows that the V-11 accumulator plays a key role in pressure stabilization and phase separation before the fluid enters the pump. Thus, the HYSYS results provide a strong qualitative basis for the potential energy of the fluid released during a failure and support the FTA and LOPA analyses.

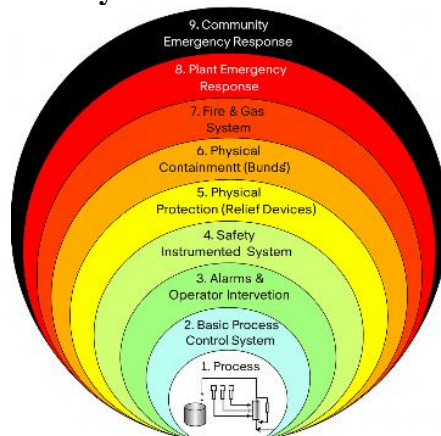
**Summary of the Layer of Protection Analysis**

The LOPA results indicate that the layered protection structure implemented in the PES HF Alkylation unit does not possess the reliability required to prevent or limit the escalation of incidents. Of the nine theoretical layers of protection evaluated, only a few provide meaningful mitigation, and only the RAD system can be considered a credible IPL according to CCPS criteria.

The first layer inherently safer design was deemed inadequate because the process continued to use HF as a catalyst even though safer alternatives were available. The BPCS layer functioned prior to the incident but lost its effectiveness immediately after the fire, demonstrating its inability to serve as an IPL in a major fire scenario.

The alarm and operator intervention layers were confirmed to be active, but were unable to alter the course of the incident due to the extremely rapid escalation. The SIS layer was only partially effective, specifically in the RAD system, which successfully reduced the HF inventory; conversely, the water mitigation system failed due to power and communication outages.

Physical barriers such as relief valves and containment systems do not provide significant protection, as evidenced by the BLEVE at V-1 and the failure of the automatic water spray system. Internal emergency response measures functioned partially, but their effectiveness was limited by physical access and the conditions at the incident site. This analysis indicates a significant risk gap, in which the frequency of residual risk remains above the tolerance level for a major HF release scenario.

The LOPA analysis also shows that most existing protection layers do not meet the criteria for an independent protection layer (IPL), primarily due to their reliance on shared resources, such as power and control systems. This results in a significant risk gap in scenarios involving a large-scale HF release. As a mitigation measure, the design of protection layers should focus on enhancing independence and reliability, rather than merely increasing their number. Active protection systems, such as alarms and operator intervention, must be supported by truly independent IPLs, so that they remain functional even in the event of a primary system failure due to fire or explosion

The failure of the water mitigation system during the incident also serves as a lesson learned that active mitigation systems are highly vulnerable to power outages and physical damage during large-scale fires. Therefore, mitigation strategies must be supplemented with enhanced passive protection measures, such as fireproofing, shielding critical equipment, and layout designs that account for the possibility of direct fire exposure. This approach aims to enhance the physical resilience of the facility so that mitigation systems can remain operational during the early stages of an incident.
