## Optimizing Vehicle Loading To Improve Operational Safety At Kmp. Dharma Ferry VIII

I Made Agustine Wikana Putra<sup>1)</sup>, Bustamin<sup>2)</sup>, Diah Vitaloka Hartati<sup>3)</sup>  
<sup>1,2,3)</sup> Nautical Study Program, Makassar Maritime Polytechnic

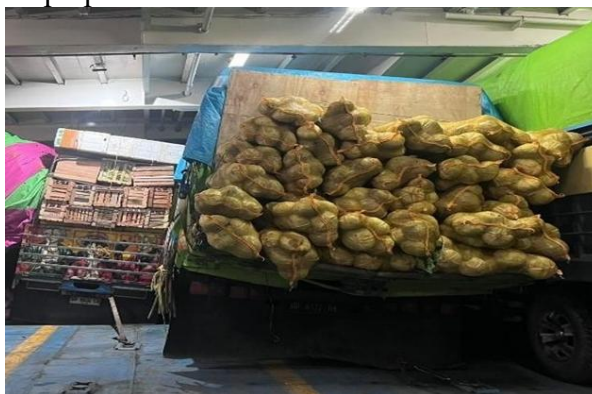
**Figure 2 Inclined and Frictional Loads**

The second case involved a large truck (TB) that tilted during its voyage from Lembar Port to Padang Bai Port due to the lashing system being unable to support the vehicle's load optimally. This condition is inconsistent with the Minister of Transportation Regulation Number 115 of 2016, which stipulates that vehicles weighing 30–40 tons must be secured using at least four lashing gears with an appropriate safe working load (SWL) on each side of the vehicle. Furthermore, the lack of re-inspection of the lashing tightness during the voyage increases the risk of load shifting, vehicle damage, ship stability disturbances, and endangers navigational safety.

**The number of lashings on the load is not correct.**

For medium to heavy-duty vehicles, the number of lashing devices used is often not commensurate with the weight and characteristics of the load. Furthermore, the lashing techniques employed are often substandard, such as using fastening angles that do not form a 45-degree angle or lashings that do not intersect. This results in suboptimal tensile and tension forces, thus rendering the load securing function ineffective.

According to IMO Resolution MSC. 479(102) (2020), to ensure optimal and safe transmission of the binding force, binding must only be performed at specific binding points directly connected to the vehicle frame (chassis), not on the bumper or axle.

Vehicles with a total weight of between 3.5 (three point five) tons and 20 (twenty) tons must use at least 2 (two) lashing gears with a suitable safe working load on each side of the vehicle.

vehicles whose total weight is between 20 (twenty) tons to 30 (thirty) tons must use at least 3 (three) lashing gears with appropriate safe working loads on each side of the vehicle;

vehicles whose total weight is between 30 (thirty) tonnes to 40 (forty) tonnes must use at least 4 (four) lashing gears with appropriate safe working loads on each side of the vehicle.

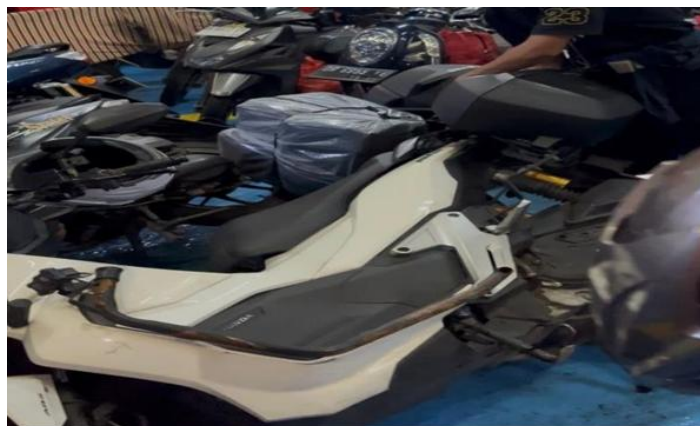
**Figure 3 Motorcycles Fall on Cardeck**

The third case involved a motorcycle falling and hitting another vehicle during a voyage from Padangbai Port to Lembar Port during Ramadan. Observations indicated that the incident was triggered by high traffic volume, excessively tight motorcycle traffic, and inadequate safety measures. These conditions caused the motorcycle to lose balance, causing damage to surrounding vehicles, such as cracked hulls and broken brake handles, and increasing the risk to ship operational safety.

**Waiver of lashing on light loads**

The lashing of light vehicles, particularly motorcycles, is often not carried out according to regulations. In some cases, motorcycles are not tied down at all, assuming they are relatively light.

This practice has the potential to cause cargo shifting, especially when the ship is undergoing significant maneuvering, which can endanger other cargo and the stability of the ship.

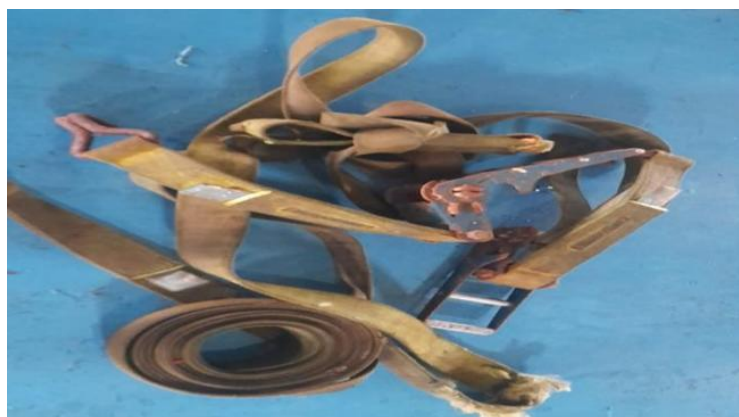
**Figure 4 Ratchet Strap Assembly**

The fourth case involved the discovery of several lashing devices that were unsuitable for use, such as worn, rusted, and jammed ratchets. Observations revealed that these conditions reduced the effectiveness of the lashing, made the cargo lashing process difficult, and increased the risk of vehicle shifting during shipping. These findings indicate that maintenance and regular inspections of the lashing devices are still suboptimal, potentially compromising the safety of cargo on the car deck.

Observations indicate that some lashing equipment, such as ratchets, chains, and hooks, is experiencing wear, corrosion, or damage, reducing the effectiveness of cargo securing. These conditions, combined with the high volume of loading activities, mean that lashing is not always carried out according to procedures. Improved maintenance and routine inspections of equipment are needed to ensure cargo safety during shipping.

Several factors can make lashing equipment difficult to use, including rust, jammed fastening mechanisms, and wear on the wire or chain due to prolonged use without regular maintenance. Furthermore, a lack of regular inspection and maintenance can also prevent lashing equipment from being ready for use when needed, hindering the lashing process and reducing load safety.
